National Transportation Safety Board

ERA22FA207

AIRWORTHINESS

Time: 1300 eastern daylight time Helicopter: Bell 429, registration N507TJ

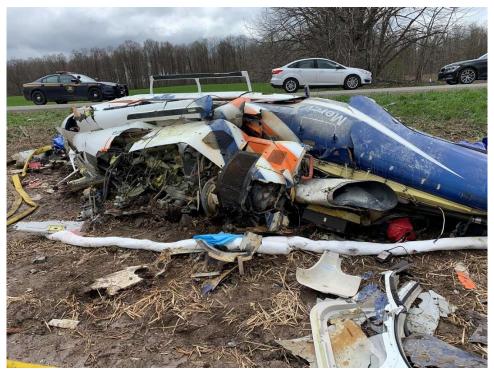
At the accident site, the fuselage had impacted terrain and came to rest on its left side (**Figure 1**). The fuselage had crushed inwards and had fractured and separated into two large sections: 1) the upper section composed of the roof structure and the forward tail boom section and 2) the lower section composed of the floor structure and landing gear.

Figure 1. The fuselage at the accident site.

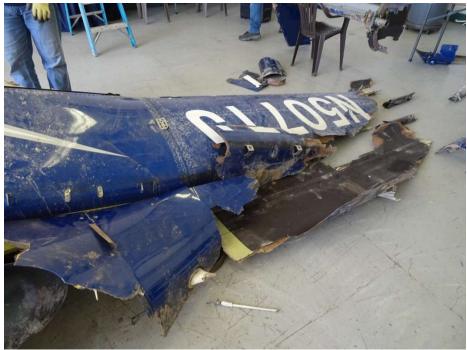
The tail boom had fractured and separated into two sections with angled fracture lines consistent with main rotor blade contact. The forward tail boom section remained attached to the upper section of the fuselage (**Figure 2**). The aft tail boom section was composed of the vertical fin and the tail rotor and was found about 400 feet away from the fuselage (**Figure 3**). A section of the tail rotor drive shaft cover exhibited an impact mark consistent with main rotor blade contact.

Figure 2. The forward tail boom section, with the right side facing up.

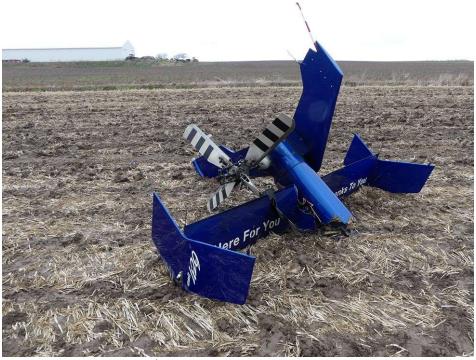
Figure 3. The aft tail boom section at the accident site.

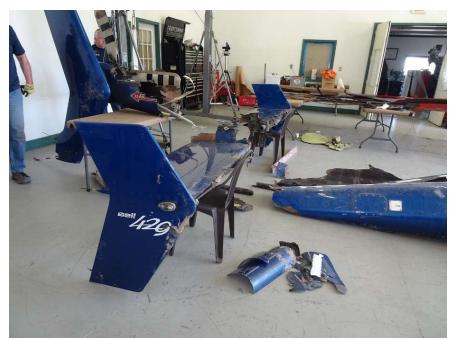
The right horizontal stabilizer was whole but most of the leading edge slats (containing the "danger" decal) had separated except for on the outboard end

(**Figure 4**). The right horizontal stabilizer finlet remained attached and was whole. The left horizontal stabilizer was whole but all of its leading edge slats had separated. The leading edge of the left horizontal stabilizer exhibited an impact mark about midspan. The left horizontal stabilizer finlet remained attached and was whole.

Figure 4. A reconstruction of the empennage showing the horizontal stabilizer, aft tail boom section, and a portion of the forward tail boom section.

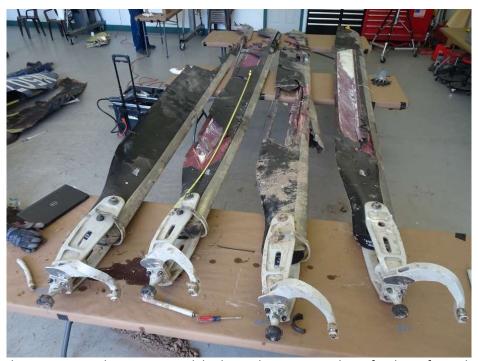
All four main rotor blades had separated from the main rotor head and were found in the debris field between the tail boom and the fuselage. The span of all four blades were recovered and their leading edges were fairly straight along the entire span (**Figure 5**). The tip ends of all four blades exhibited impact marks. Substantial portions of the blade afterbody were not present on the 'orange', 'blue', and 'green' main rotor blades and their spars exhibited fractures with a broomstrawed appearance. The 'red' main rotor blade afterbody was generally whole and its leading edge did not exhibit significant fractures. On the lower surface of the 'blue' main rotor blade, an impact gouge was present, its location (about 89 inches from the inboard blade bolt) and size consistent with the antenna mounted immediately aft of the engine exhaust pipes (**Figure 6**).

Figure 5. The recovered main rotor blades. They were identified as (from left to right) 'orange', 'blue', 'green', and 'red'.

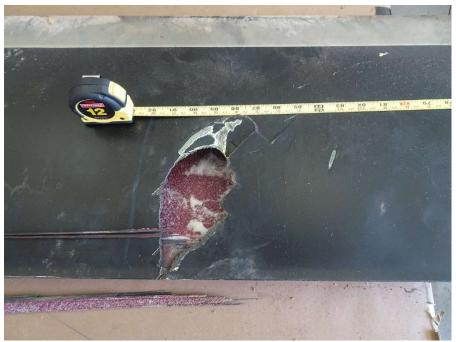
Figure 6. The impact gouge on the lower surface of the 'blue' main rotor blade.

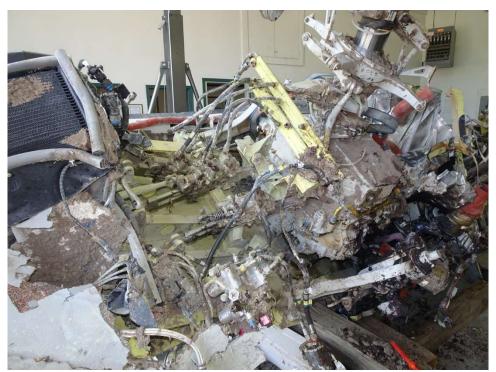
The cyclic and collective push-pull tubes, routed up the right side of the cockpit frame, were cut during recovery of the helicopter. With the exception of this cut, the longitudinal push-pull tube was continuous to the forward [of the two] pitch SCAS actuator. The control tube between the two pitch SCAS actuators was present but had fractured on both ends with signatures of overload. The aft [of the two] pitch SCAS actuator remained connected to the longitudinal servo actuator. The longitudinal servo actuator's aft support had fractured and separated from its support structure, but its attachment hardware was present (**Figure 7**). The control tube between the longitudinal support bellcrank and the stationary swashplate was not present, but its rod end remained connected to the stationary swashplate.

Figure 7. The three main rotor servo actuators.
